INDOOR AIR QUALITY ASSESSMENT

**Greenfield Town Hall Annex
253 Main Street
Greenfield, Massachusetts**

Prepared by:
Massachusetts Department of Public Health
Bureau of Environmental Health Assessment
November, 2001

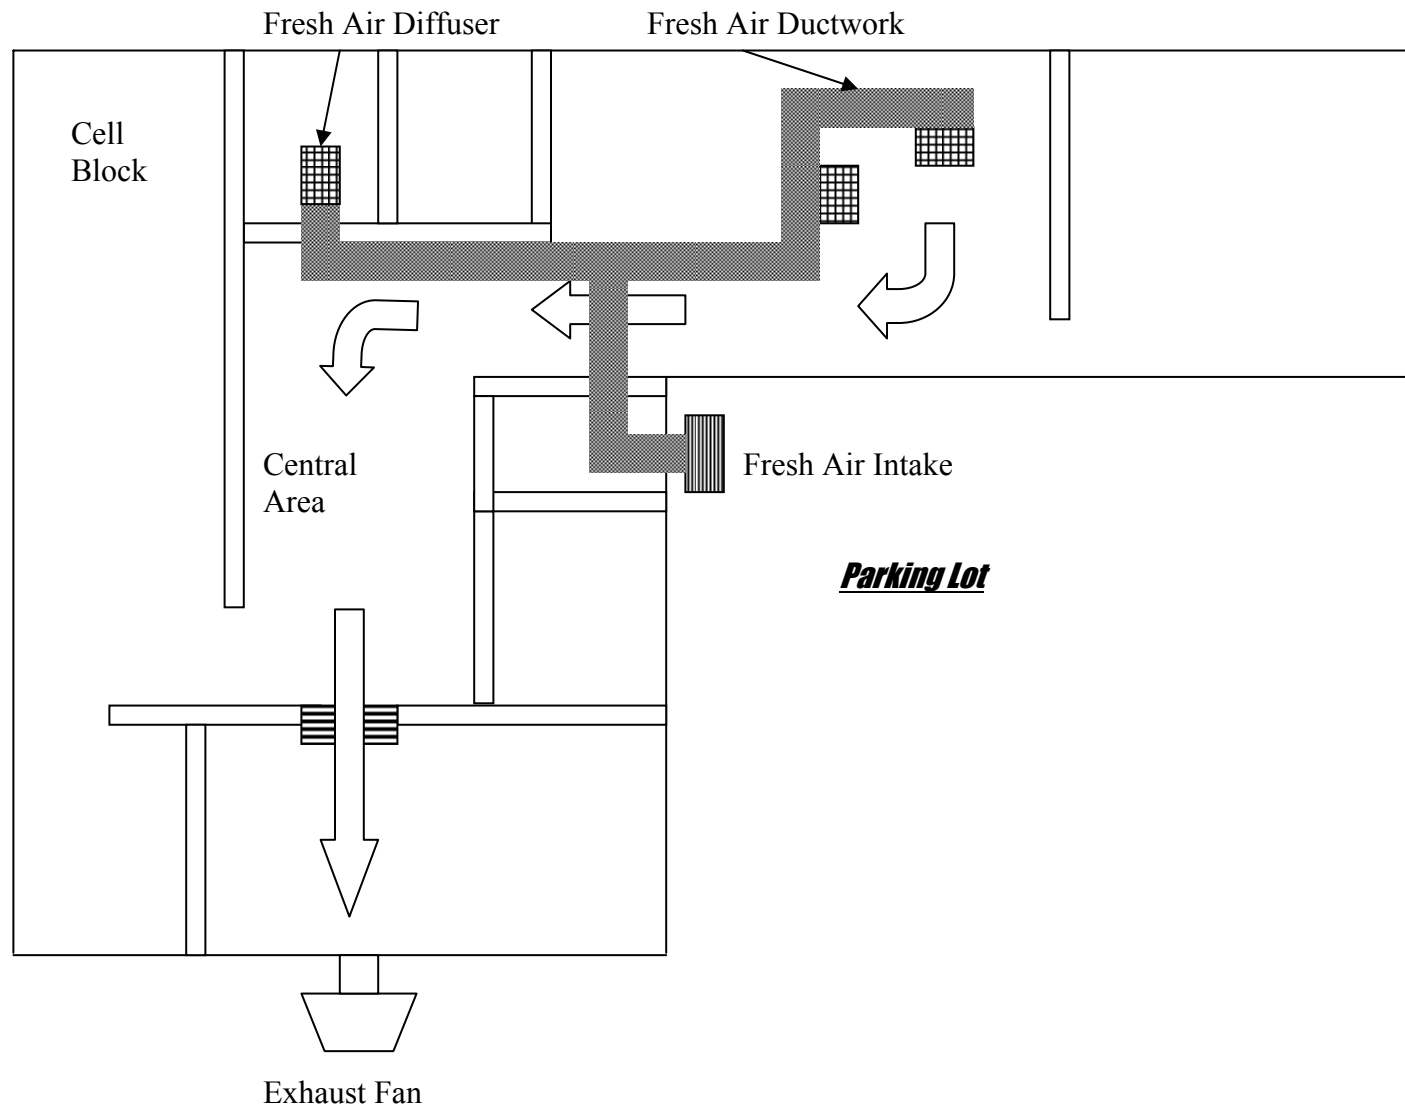
Figure 2
Configuration of Town Hall Annex Ventilation System

The annex appears to have been equipped with a mechanical ventilation system (see Figure 2). An air handling unit (AHU) was located above the suspended ceiling in a restroom (see Picture 4). The AHU is connected to a fresh air intake located near the back corner formed by the police station and the 1960s addition (see Picture 5, Figure 2). The AHU was deactivated by the cutting of its power cord (see Picture 6). It appears that the AHU is connected to ceiling-mounted fresh air diffusers that are in the front of the

building. It is possible that this system was disconnected to prevent the entrainment of vehicle exhaust from idling vehicle parked beneath the fresh air intake when the building was used as the police station. A large exhaust fan was installed in the rear of the annex (see Pictures 7 and 8). It appears that the operation of the exhaust fan was intended to draw fresh air from the front of the building into the rear offices (see Figure 2). In the current condition, no fresh air is provided for the meeting room, front lobby/meeting area nor the front private office. By forcing air into the front of the building, the pressurization of the interior space would aid in forcing exhaust pollutants out of the roof mounted skylight vents and into the cellblock area.

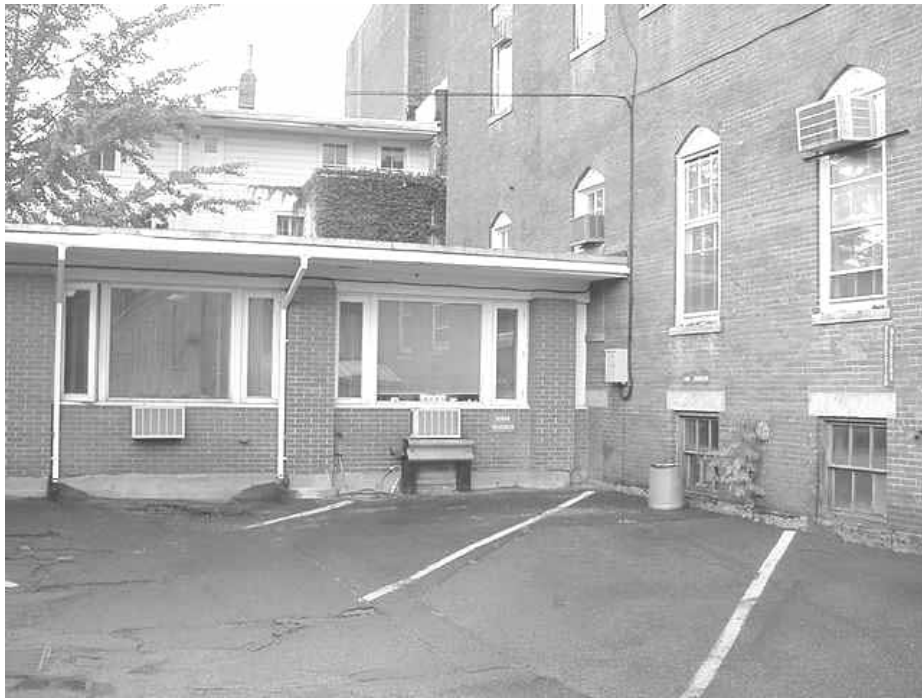
Picture 1

The First Renovation Connected The Police Station To The Greenfield Town Hall

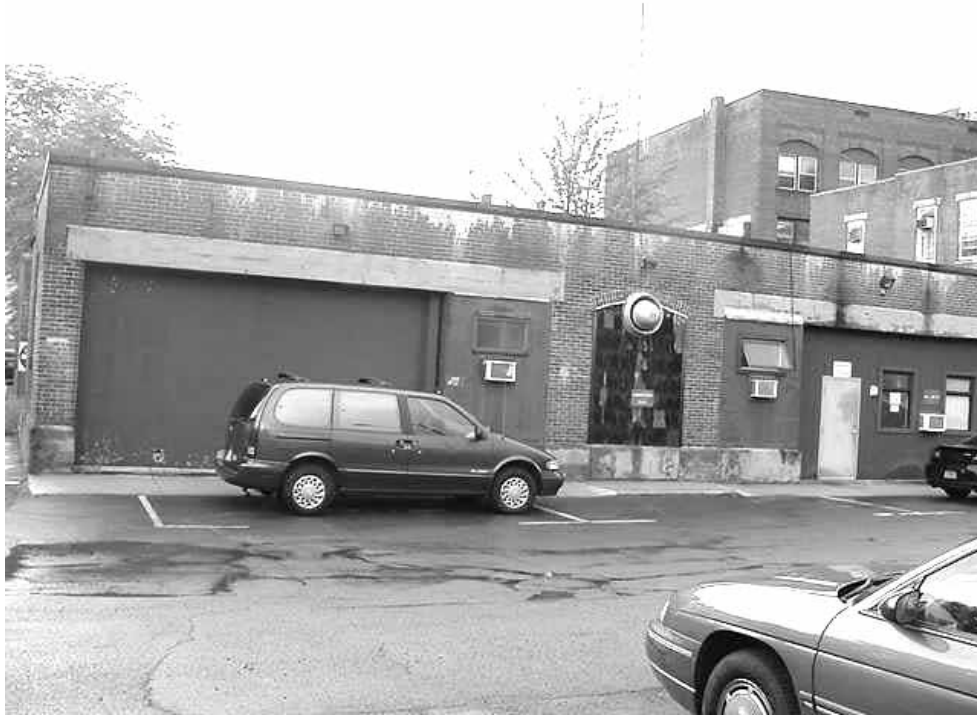
Picture 2

Garages Reconfigured Into Office Space

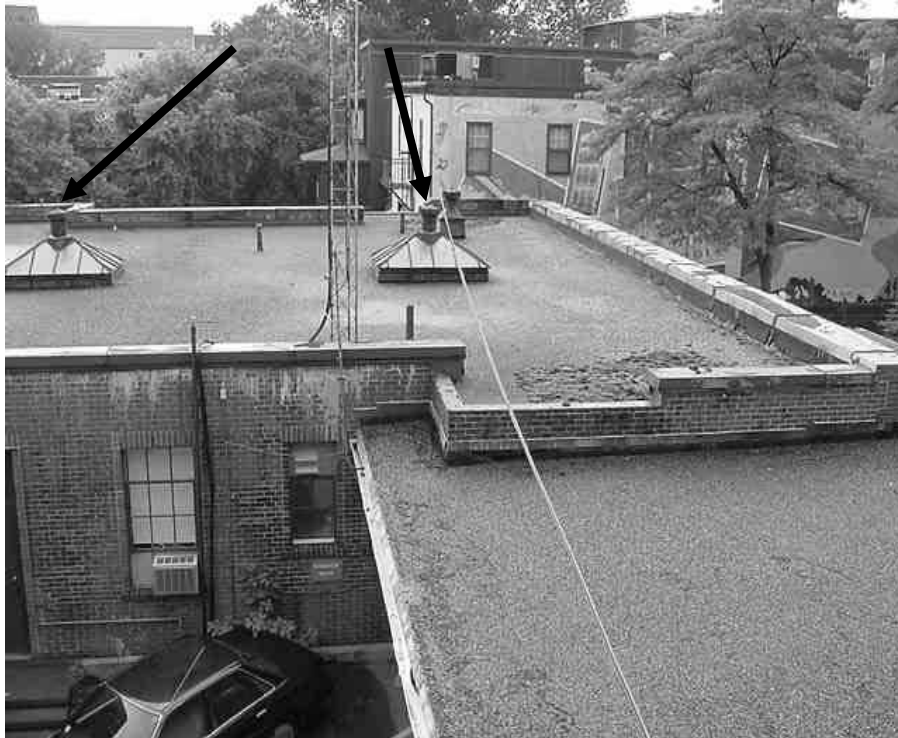
Picture 3

It can be seen from the tables that carbon dioxide levels were below 800 parts per million of air (ppm) in all areas sampled, indicating adequate air exchange. The original police station used a combination of openable windows for fresh air and turbine vents (see Picture 3) installed in skylights for exhaust ventilation. At the time of the assessment, the annex staff used a combination of window and wall-mounted air conditioners to provide cooling and the skylight-mounted turbine vents for exhaust ventilation.

Turbine Vents On Roof Of Annex

- 6) To aid exhaust ventilation, consider installing motorized exhaust fans in the skylight exhaust vents.
- 7) For buildings in New England, periods of low relative humidity during the winter are often unavoidable. Therefore, scrupulous cleaning practices should be adopted to minimize common indoor air contaminants whose irritant effects can be enhanced when the relative humidity is low. To control for dusts, a HEPA filter equipped vacuum cleaner in conjunction with wet wiping of all surfaces is

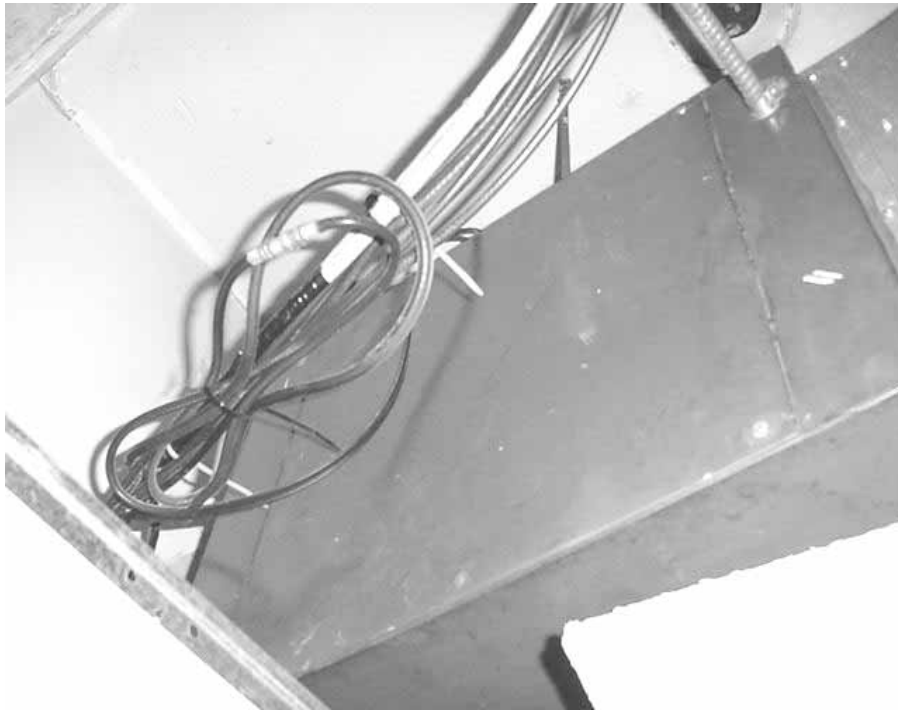
Picture 4

No means for installing air filters in the deactivated AHU could be identified. In this condition dust, dirt and other debris can be re-aerosolized by the ventilation system. In order to decrease aerosolized particulates, disposable filters with a higher dust spot efficiency should be installed. The dust spot efficiency is the ability of a filter to remove particulates of a certain diameter from air passing through the filter. Filters that have been determined by ASHRAE to meet its standard for a dust spot efficiency of a minimum of 40 percent would be sufficient to reduce airborne particulates (Thornburg, D., 2000; MEHRC, 1997; ASHRAE, 1992). Note that increased filtration can reduce airflow produced by the unit due to increased resistance (called pressure drop). Prior to any increase of filtration, the AHU should be evaluated by a ventilation engineer to ascertain whether it can maintain function with higher efficiency filters.

Air Handling Unit (AHU) Located Above The Suspended Ceiling In A Restroom

- 3) Ensure that a means to install disposable filters of a sufficient dust spot efficiency is provided in the AHU to remove outdoor particles from fresh air.

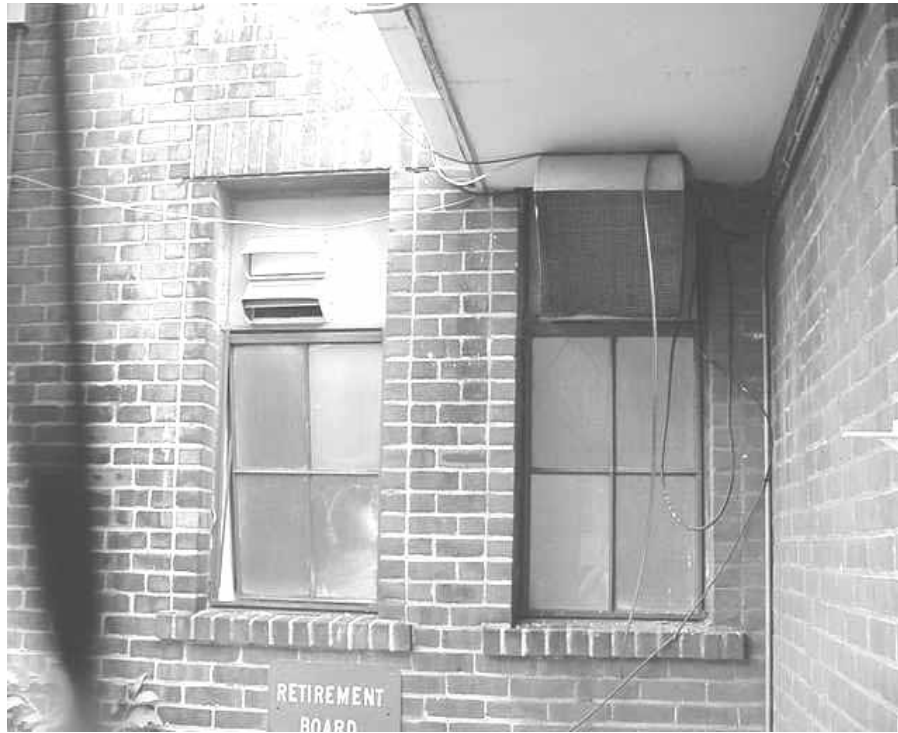
Picture 5

The location of the fresh air intake would indicate that this system was deactivated due to entrainment of vehicle exhaust from idling vehicles. Under certain weather conditions this may provide opportunities for exposure to combustion products such as carbon monoxide. M.G.L. chapter 90 section 16A prohibits the unnecessary operation of the engine of a motor vehicle for a foreseeable time in excess of five minutes (MGL, 1986).

This AHU Is Connected To A Fresh Air Intake Located Near The Back Corner Formed By The Police Station And 1960s Addition

- 1) Restore the bevel of the meeting room WMAC to drain condensation outdoors. Examine the GW around the WMAC and if moldy, remove.
- 2) Restore the fresh air supply system. If restoration occurs, consideration should be given to either:
 - a) Extending the fresh air intake to rooftop level to prevent vehicle/restroom exhaust entrainment, or

- b) Preventing vehicles from parking in this area and reconfiguring the restroom exhaust vent to expel air in a direction away from the fresh air intake.

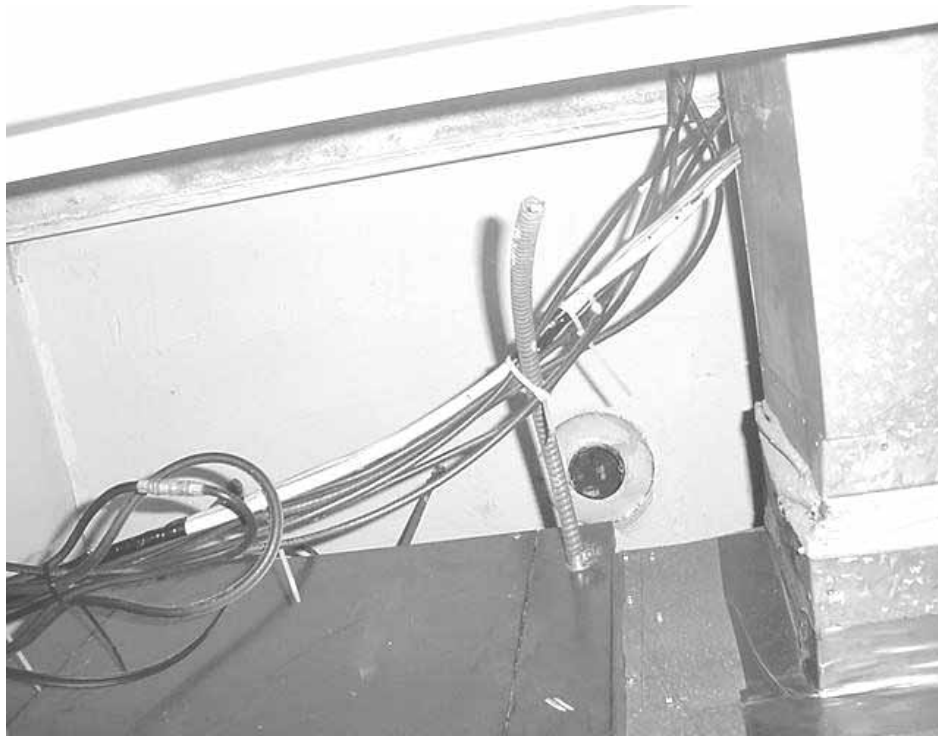
Picture 6

The AHU Was Deactivated By The Cutting Of Its Power Cord

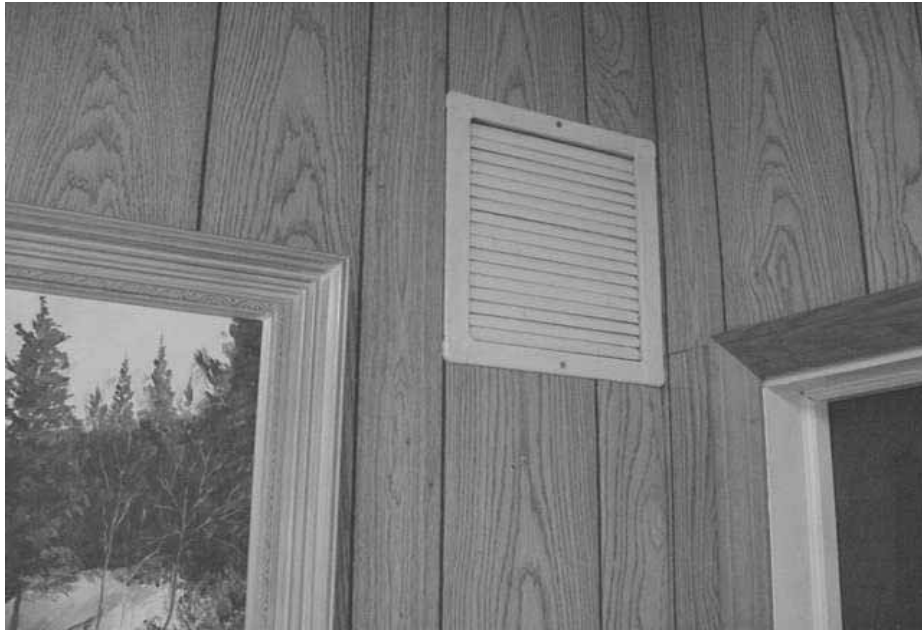
Picture 7

Exhaust Vent Grill Connected To The Large Exhaust Fan Installed In The Rear Of The Annex

- 5) Once the fresh air supply system is reestablished, the system should operate to pressurize the occupied offices within the old police station. The existing exhaust vent system in the rear of the building should not operate in a manner to depressurize the rear offices, since this condition would result in the drawing of air through the adjacent garage as well as air from the cellblock.

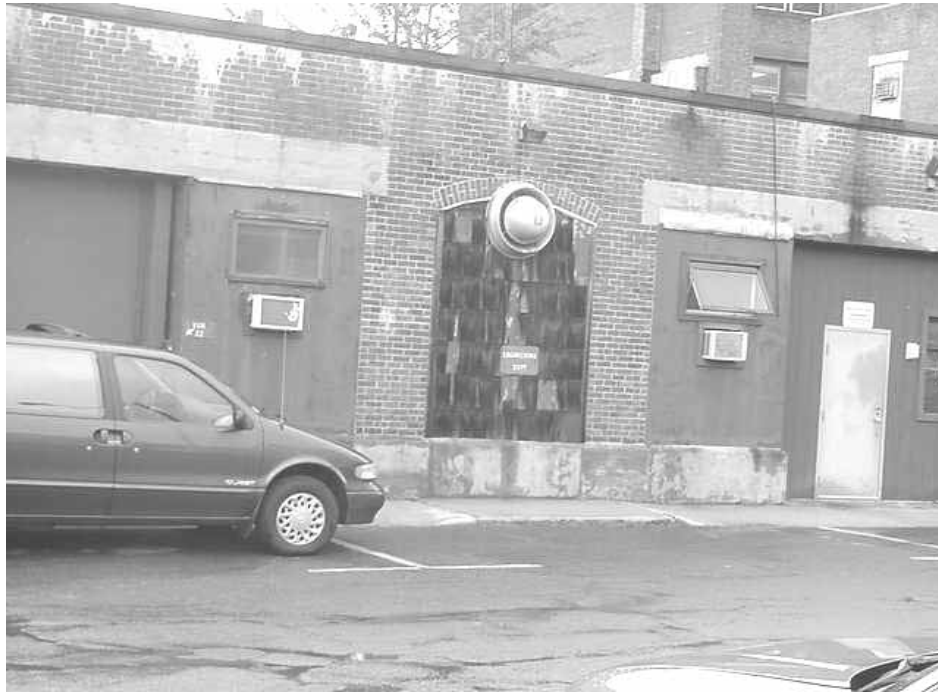
Picture 8

Large Exhaust Fan Installed In The Rear Of The Annex

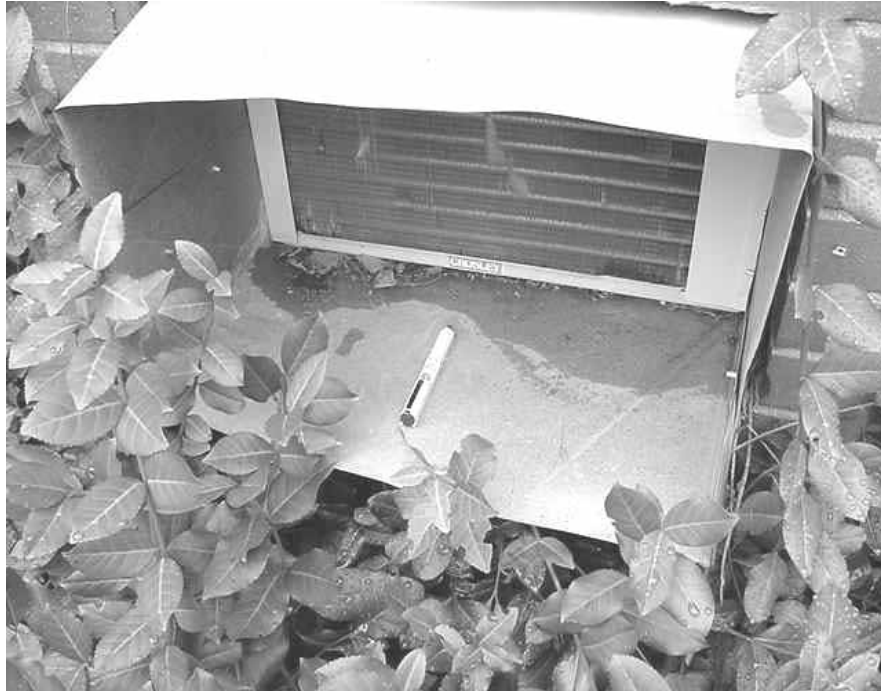
Picture 9

A number of areas have wall-mounted air conditioners (WMACs). The meeting room has a WMAC installed through the front exterior wall within a metal sleeve. The metal sleeve should be beveled to allow for condensation to drain to the ground. The metal sleeve is beveled toward the WMAC, allowing condensation to drain into the interior wall (see Picture 9). The interior wall of the meeting room is made of gypsum wallboard (GW). If GW becomes chronically moistened, it can become a mold growth medium. The American Conference of Governmental Industrial Hygienists (ACGIH) recommends that porous materials be dried with fans and heating within 24 hours of becoming wet (ACGIH, 1989). If porous materials are not dried within this time frame, mold growth may occur. Once mold growth has occurred, disinfection of these materials may be possible, however since GW is a porous surface, disinfection is likely to be ineffective.

**Metal Sleeve Is Beveled Toward The WAC Allowing Condensation To Drain Into The Interior Wall,
Note Accumulated Moisture At Base Of WAC**

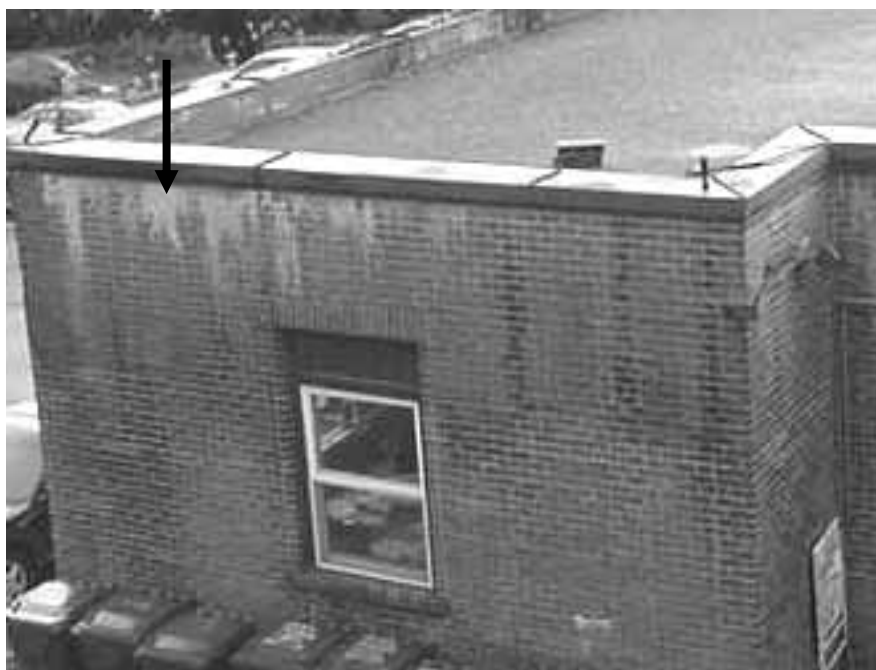
Picture 10

Several notable conditions concerning roof water drainage were observed. Both efflorescence (see Pictures 10 and 11) and water damage to wood forming the soffit of the roof (see Picture 12) were noted, which can indicate chronic exposure to rainwater penetrating beneath the flashing along the edge of the roof. Efflorescence is a

characteristic sign of water damage to brick and mortar, but it is not mold growth. As moisture penetrates and works its way through mortar around brick, water-soluble compounds in bricks and mortar dissolve, creating a solution. As the solution moves to the surface of the brick or mortar, the water evaporates, leaving behind white, powdery mineral deposits. Over time, this condition can result in the breakdown of brick and mortar. This condition can indicate that roof drainage is inadequate. Two areas of the roof have large patches of moss (see Picture 13), which may indicate the location of blocked roof drains. Pooling water on a flat roof can lead to damage during the winter. Water can penetrate into cracks on roof material or flashing, which then can freeze and thaw, resulting in damage to these materials.

Efflorescence On Brick

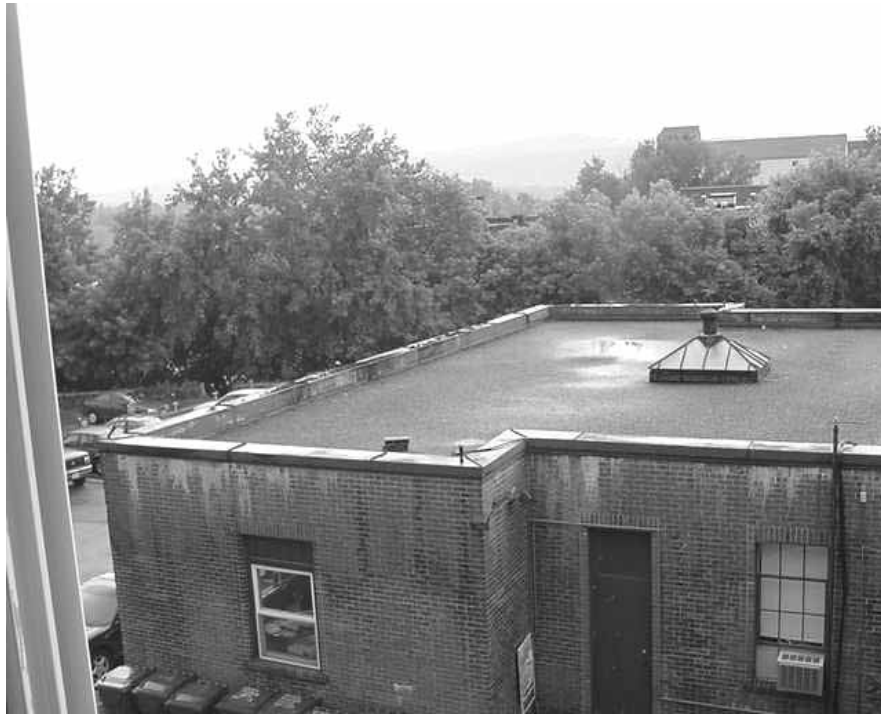
Picture 11

Efflorescence/Pooling Water On Roof

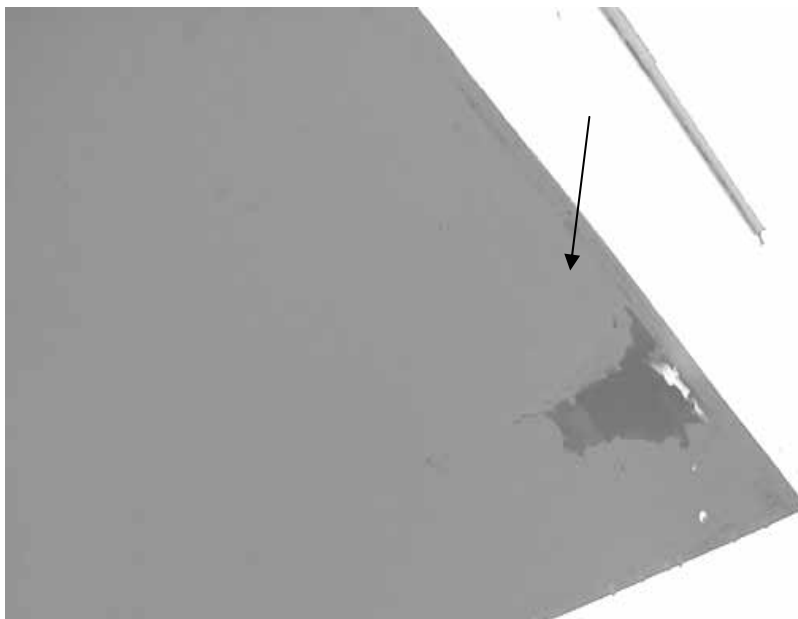
Picture 12

Water Damage To Wood Forming The Soffit Of The Roof

- 8) Remove moss from the roof. If roof drains exist under moss, clear blockages and repair. Inspect periodically for proper function.
- 9) Remove plants from the exterior wall/tarmac junction.
- 10) Clean and repair roof gutter to aid rainwater drainage.
- 11) Improve drainage along the exterior wall to direct rainwater away from the base of the building.
- 12) Cut back shrubbery a minimum of three feet to prevent water impingement on exterior brickwork.
- 13) Examine the feasibility of providing local exhaust ventilation for the photocopier.
- 14) Continue to operate firearms range exhaust vent. Restrict access to the firing area in a manner described earlier in this report. If this area is proposed for use, it is highly recommended that it be evaluated for lead contamination.

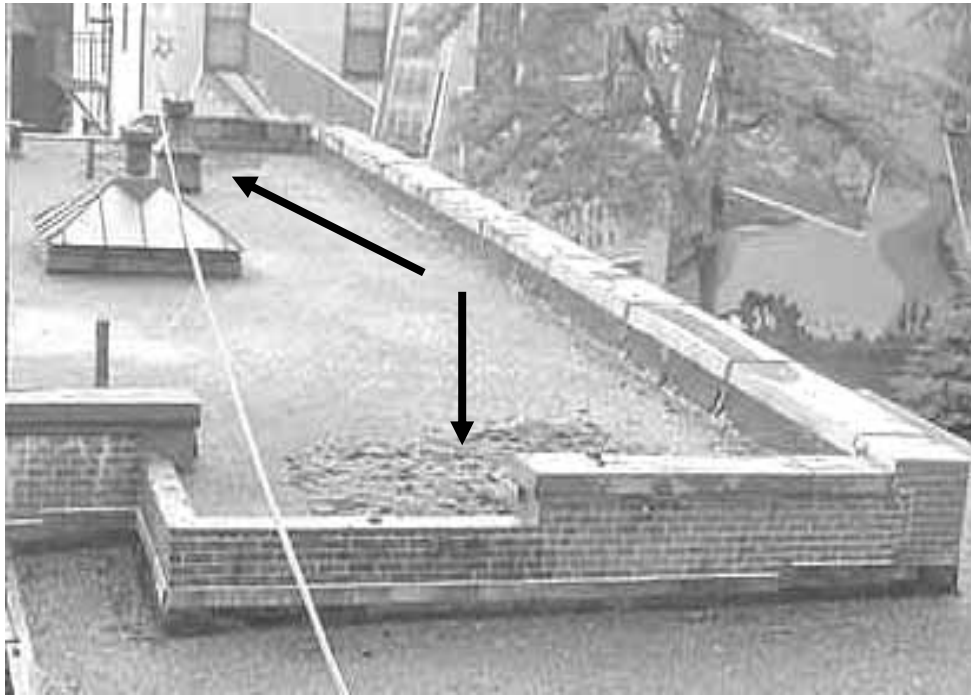
Picture 13

Enhancing the accumulation of odors in the cell block is the lack of exhaust ventilation. A skylight vent (see Picture 13) exits in the ceiling of the cell block. If this vent is closed, no means for exhausting odors from the cell block exists. If the retrofitted exhaust vent in the OPCD office is operated, this fan will tend to draw cell block odors into the occupied areas.

Two Large Patches Of Moss On Annex Roof

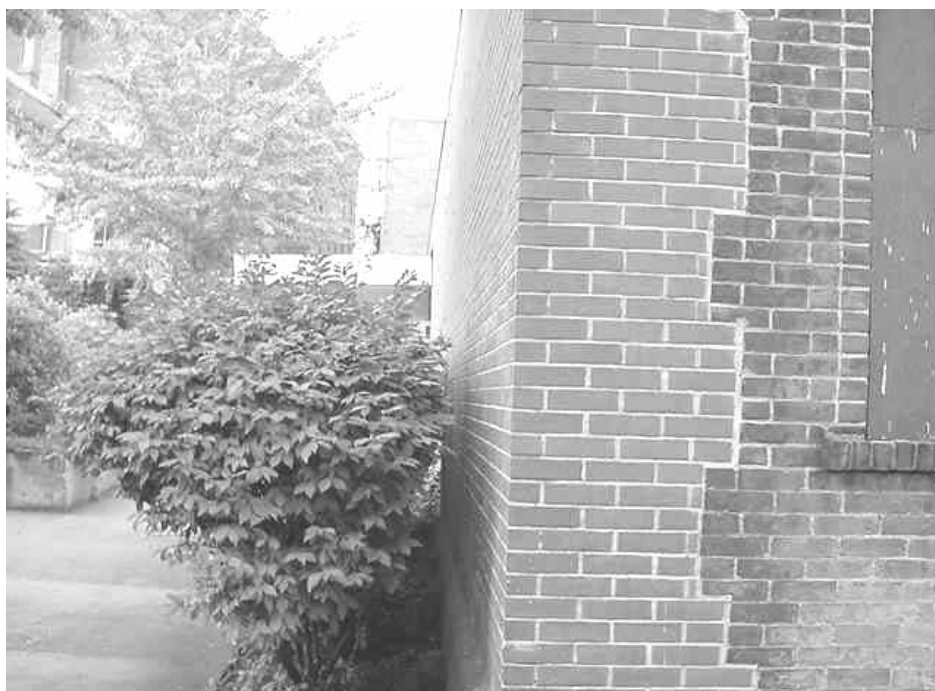
Picture 14

Shrubbery in direct contact with the exterior wall brick was noted in several areas around the building (see Picture 14). Shrubbery can serve as a possible source of water impingement on the exterior curtain wall of the building. Plants retain water and in some cases can work their way into mortar and brickwork causing cracks and fissures, which may subsequently lead to water penetration and possible mold growth.

Shrubbery In Direct Contact With The Exterior Wall Brick

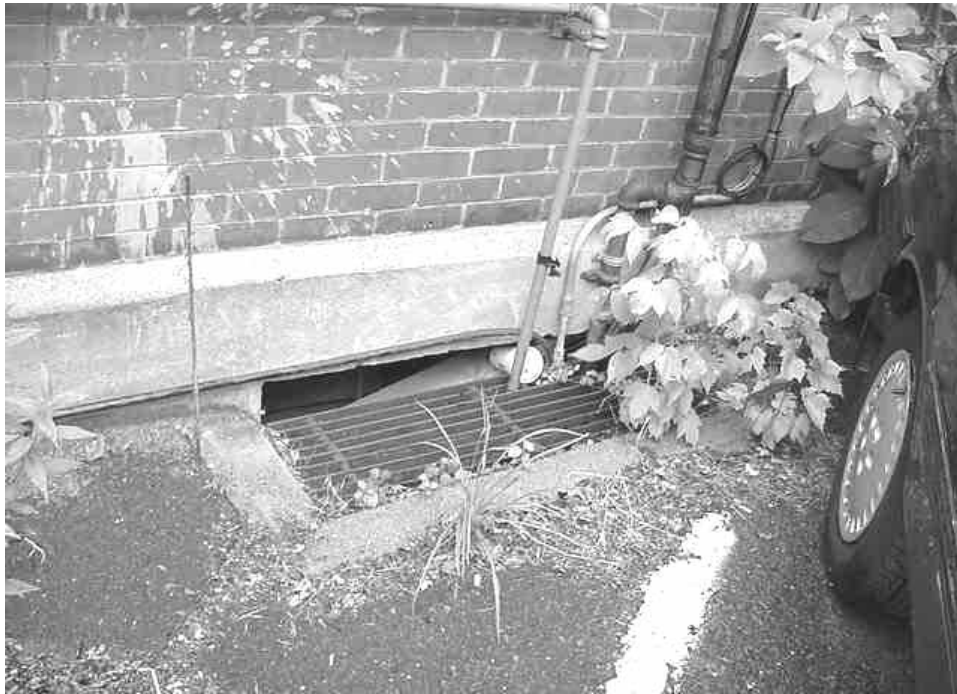
Picture 15

Opportunity for water penetration through the building envelope exists along the exterior wall/tarmac junction. Plants were noted growing in this area (see Picture 15). Water can gather in the wall/tarmac seam. Freezing and thawing of pooled water can

result in damage to the exterior wall, which can lead to water penetration into the building.

**Plants In The Wall/Tarmac Seam
Beneath The Grille Is The Exhaust Vent For The Basement Firearms Range**

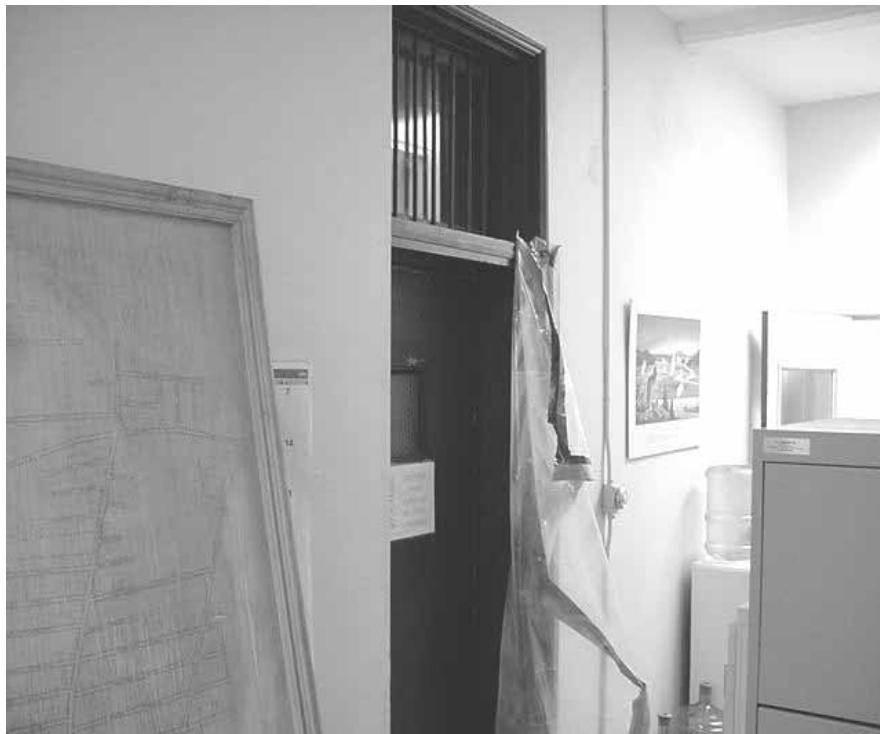
Picture 16

A number of unused floor drains and toilets exist in the former lock up. Without draining water, each of these can potentially have dry drain traps. If drain traps dry out,

sewer gas can back up the drains and enter occupied areas. In an effort to prevent odors from penetrating into occupied space, the entrance is sealed polyethylene plastic and duct tape (see Picture 16). Sewer gas can create nuisance odors and be irritating to certain individuals.

Entrance To The Cellblock Sealed With Polyethylene Plastic And Duct Tape
